## **2100-TSR ADAPTER REPLACEMENT SLIDER FOR USGS TOP-SET WADING ROD USED WITH MODEL 2100 AND 3000 CURRENT METERS**

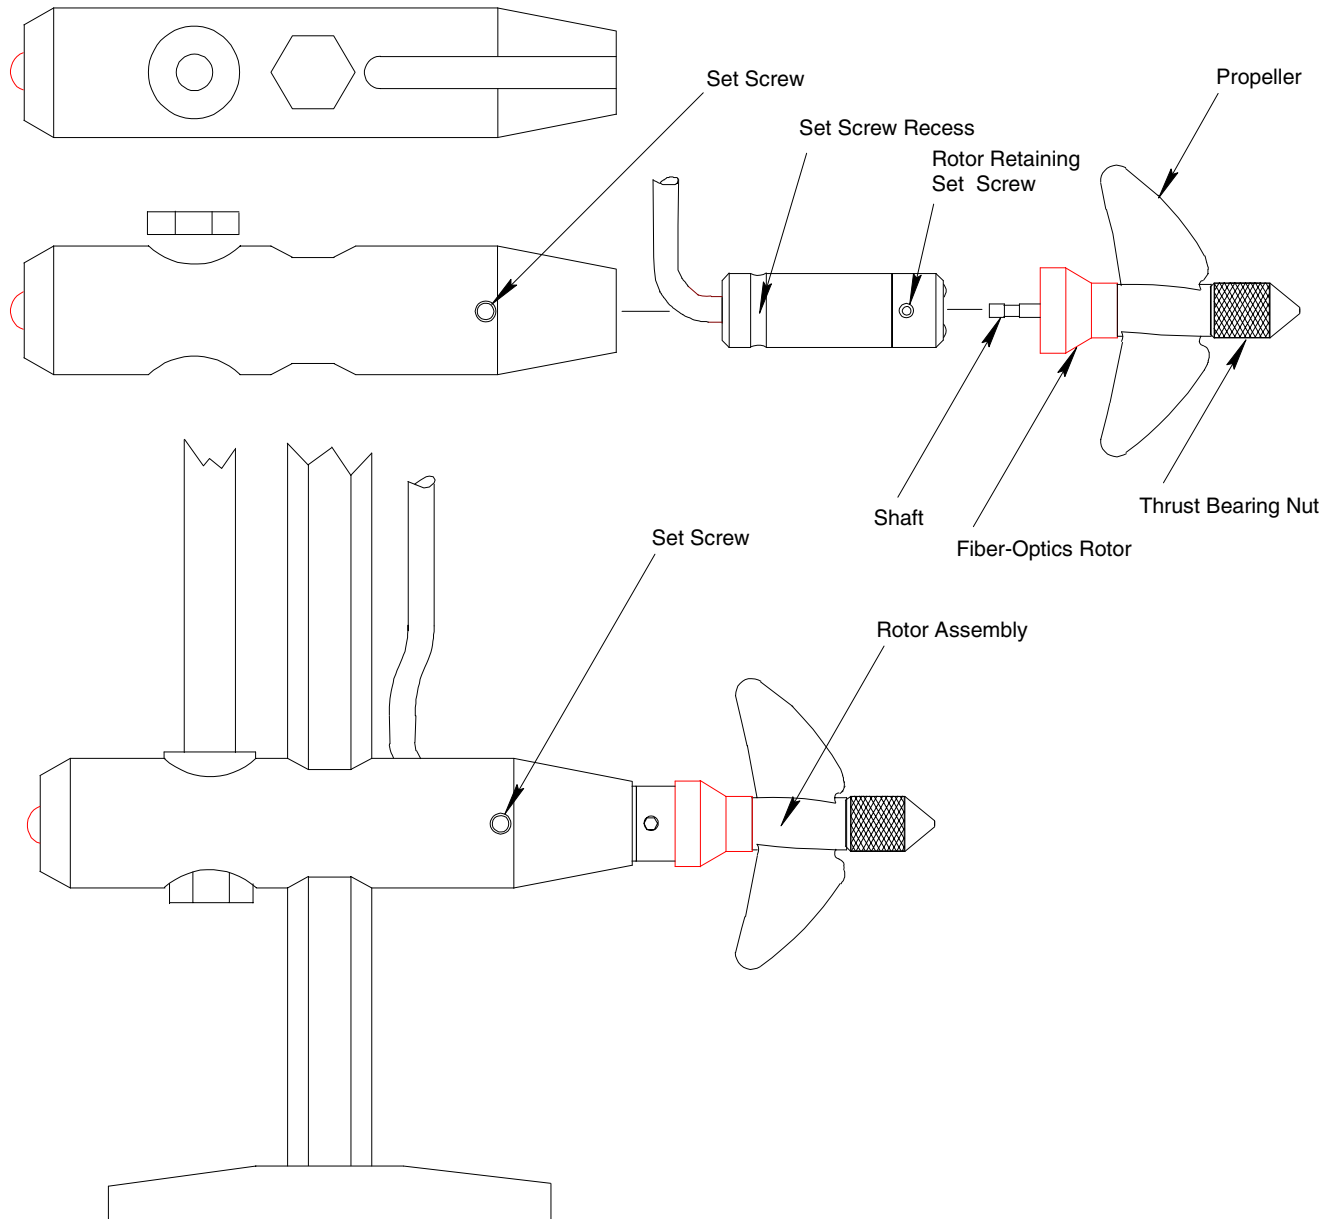
The **2100-TSR Adapter** is an acetal resin plastic part designed to replace the sliding assembly on the U.S. Geological survey's Top Set wading rod. This replacement part allows use of the Top Set rod in the normal manner but with the added convenience and accuracy of the Model 2100 Sensor and 2100 or 3000 Indicator. The **2100-A22** Sensor slips easily in and out of the **TSR Adapter** for safe and easy transport.
